Peabody C. C. #9

Illinois Coal Report 1918 + 1954 p. 73

COAL MINE OPERATOR

COAL MINE—PRODUCTION

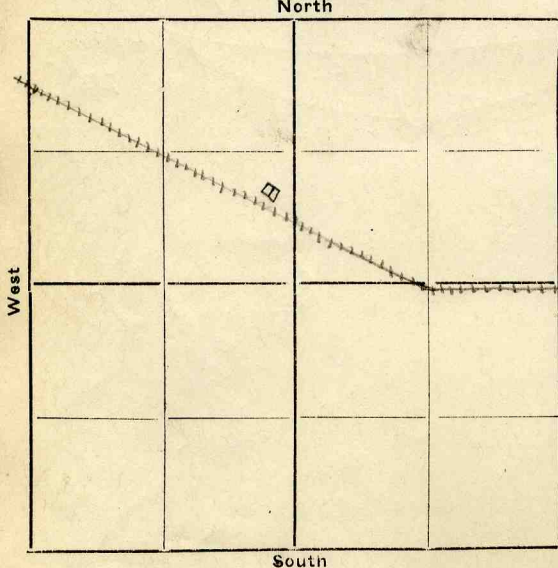
V—MINE LOCATION SHEET.

Indicate location of mine and position of R. R. in plat of section below.  
North

Kindly state number of feet from quarter section lines:

1800 from N. line

150 from E. line
