KERR- MCGEE CORP.

GALATIA MINE

Mine Index No. 1001
Coal Report No. S-61

The purpose of our visit is to observe the geological conditions at this mine. The Kerr-McGee personnel would like us to evaluate their mine roof conditions, and perhaps suggest some means of improving their roof control.

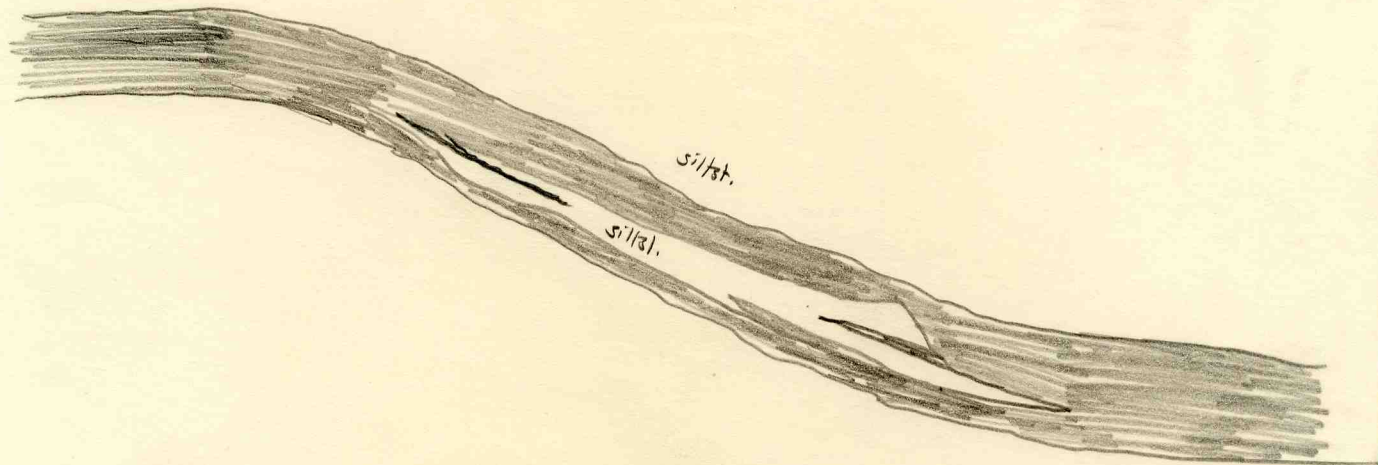
Generalized section across
eastern end of disturbance

Northwest of the disturbance the coal is 30-40 feet higher in elevation. It plunges abruptly down to the southeast. In one entry the upper portion is clearly eroded beneath siltstone-sandstone; coal layering is truncated, and stringers splay off into the roof.
